SPACE SHUTTLE PROGRAM

Fondu Fyre Historical Liberation (Action Response for Debris Integration Group) (DIG)

Engineering Review Board (ERB) 8/05/08

Tom Hoffmann NASA Engineering Integration
Basil Economou USA Ground Ops

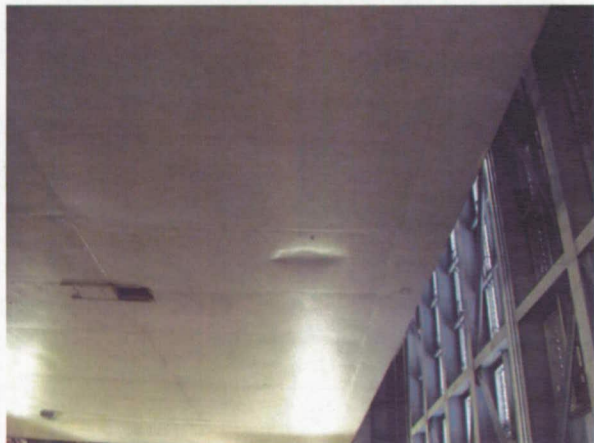
- A reliable USA Structures Engineer recalls a large dent appearing on the underside of MLP-3 approximately 6 years ago after a launch. The dent originally had rust markings corresponding to the pattern of Fondu Fyre grid steel.
- No documentation was found recording the event at that time.
- The MLP has since been repainted, but still has the large dent.

Dent on MLP Underside

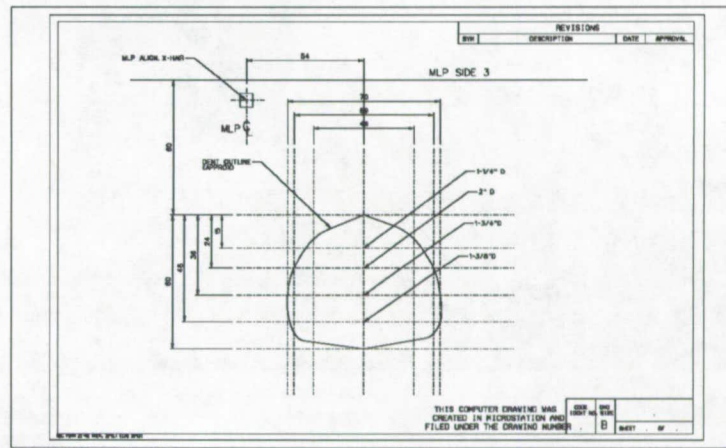
Dent on MLP Underside
